# I-5 /Spokane Street Interchange – Expansion Joints

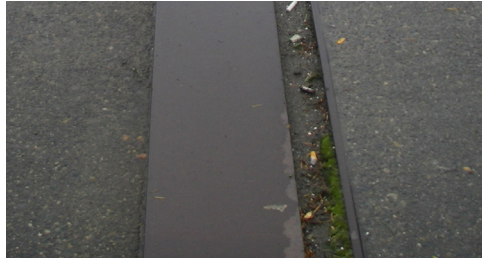
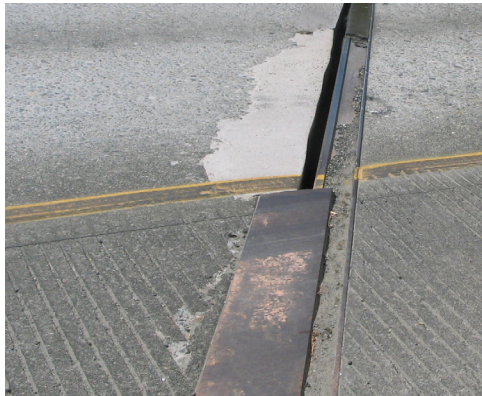
## Expansion Joint

The 50-year-old joints have undergone numerous repairs over the years. Additionally, the steel plate coverings on top of the roadway are coming apart, are loose or have been completely removed due to age and heavy traffic.

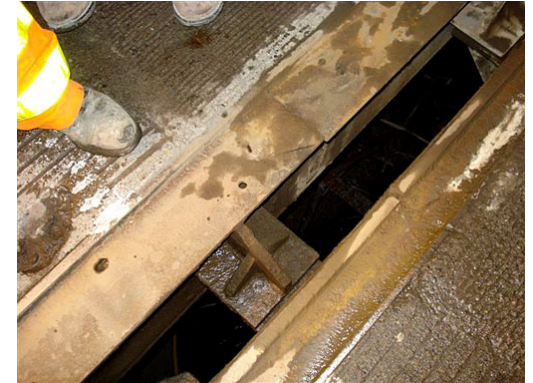
## Expansion Joint

A look inside an expansion joint without the steel plate cover. This gap allows the concrete slabs that make up the bridge to expand and contract as the temperature changes. Crews will fill this gap in with concrete and a flexible rubber strip seal.
